**CANADIAN FORCES
FLIGHT SAFETY INVESTIGATION REPORT (FSIR)**

FINAL REPORT

FILE NUMBER: 1010-CU161005 (DFS 2-4)
DATE OF REPORT: 18 November 2005

AIRCRAFT TYPE: CU161 SPERWER Unmanned Aerial Vehicle (UAV)
DATE/TIME: 201247Z January 2004
LOCATION: Camp JULIEN, Afghanistan
CATEGORY: "A" Category Accident

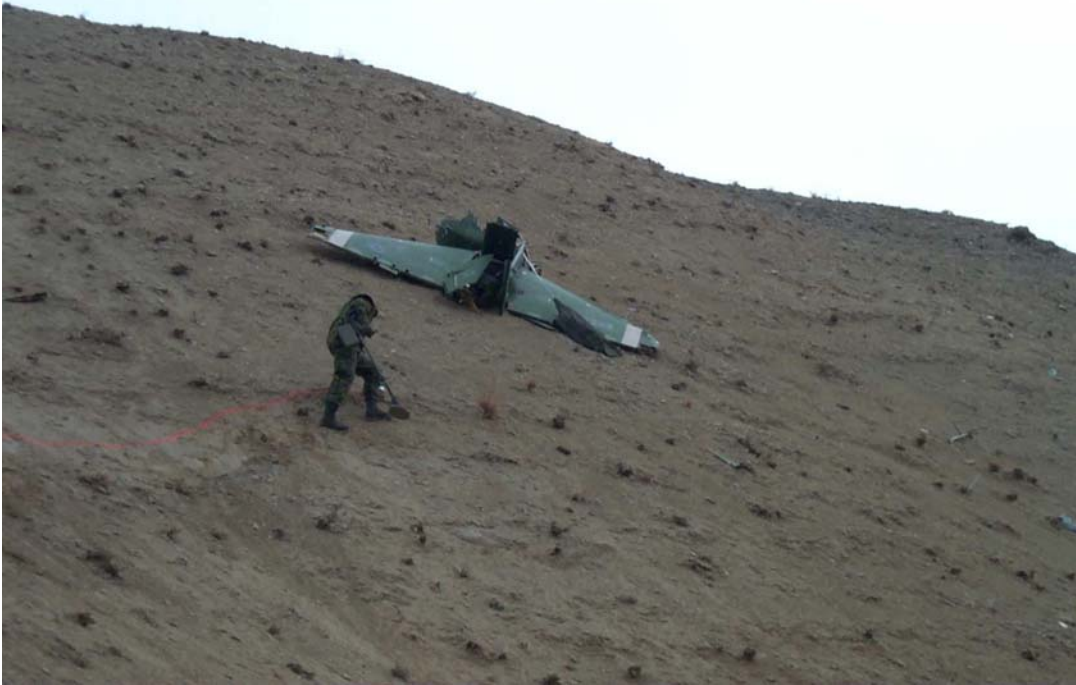
The UAV impacted the side of a hill in an un-cleared terrain while in a left bank, shallow angle, descending turn, at a speed of 52 meters per second (52m/s) (approximately 105 kts). The UAV came to rest several meters from the crest of the hill. Parts and debris from the initial impact point to the final resting point were strewn down hill from the crash path. The hill incline exceeded 45 degrees. Most of the UAV wreckage remained within the immediate impact area. The debris field was limited to pieces of fuselage, electronics and airframe panels.

Photo 1: Final resting place

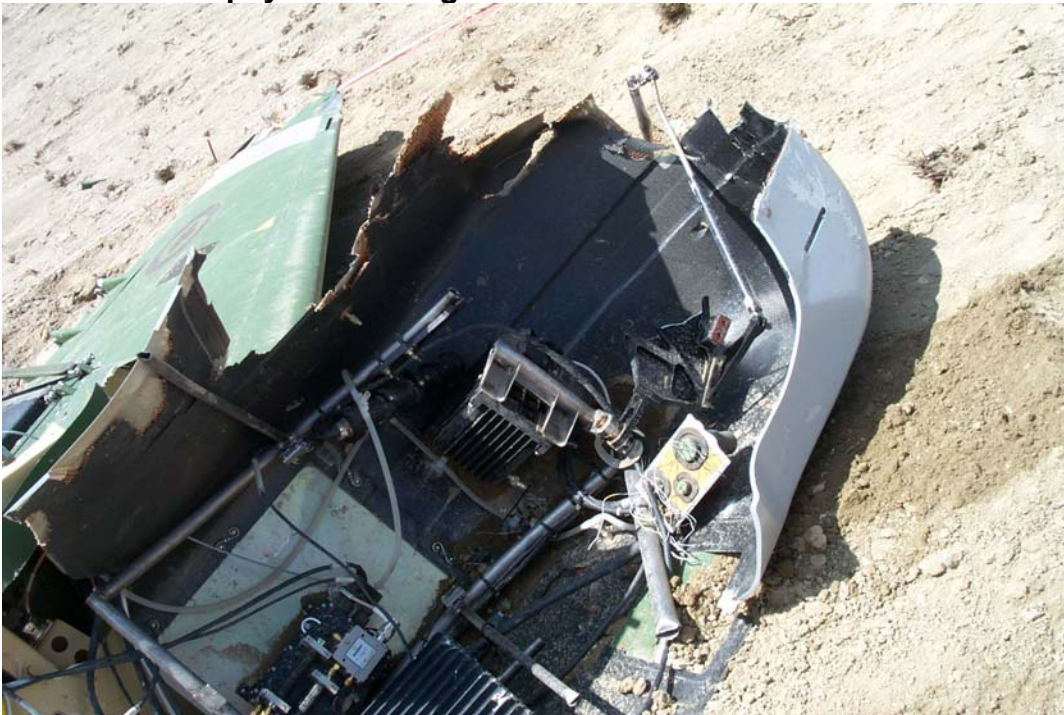
The UAV suffered "A" category damage as a result of the crash. The vehicle's frame was fractured in several areas and there was severe damage to the wings, vertical stabilizers, nose and payload.

Photo 2: Nose/payload damage

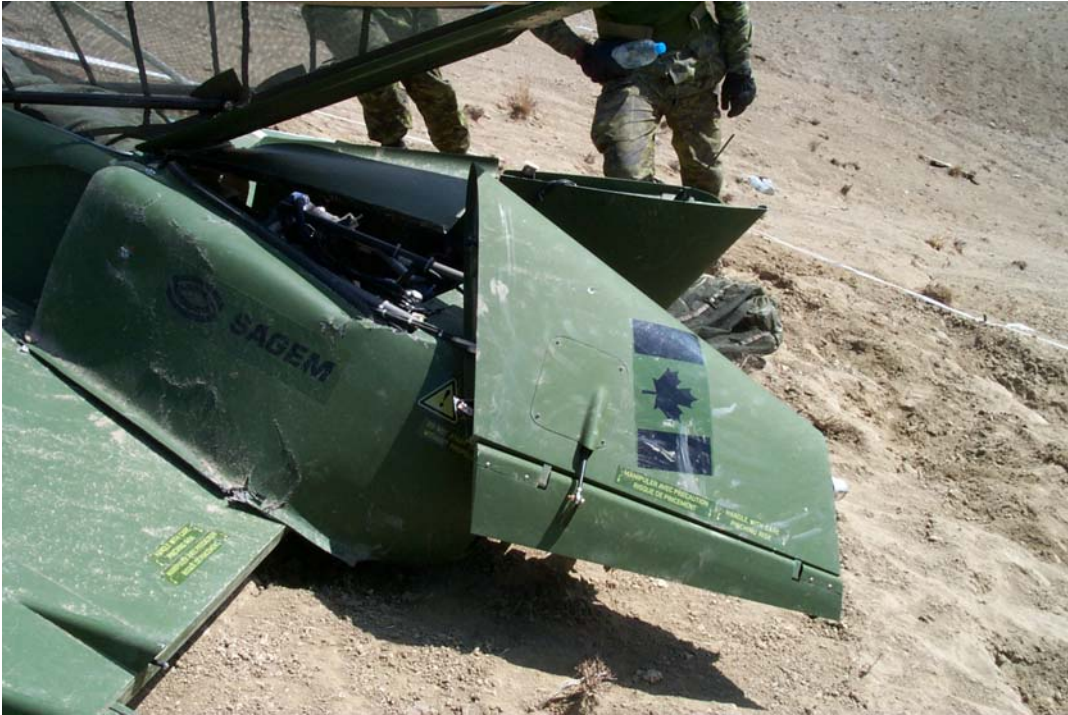
Photo 3: Vertical Stabilizers

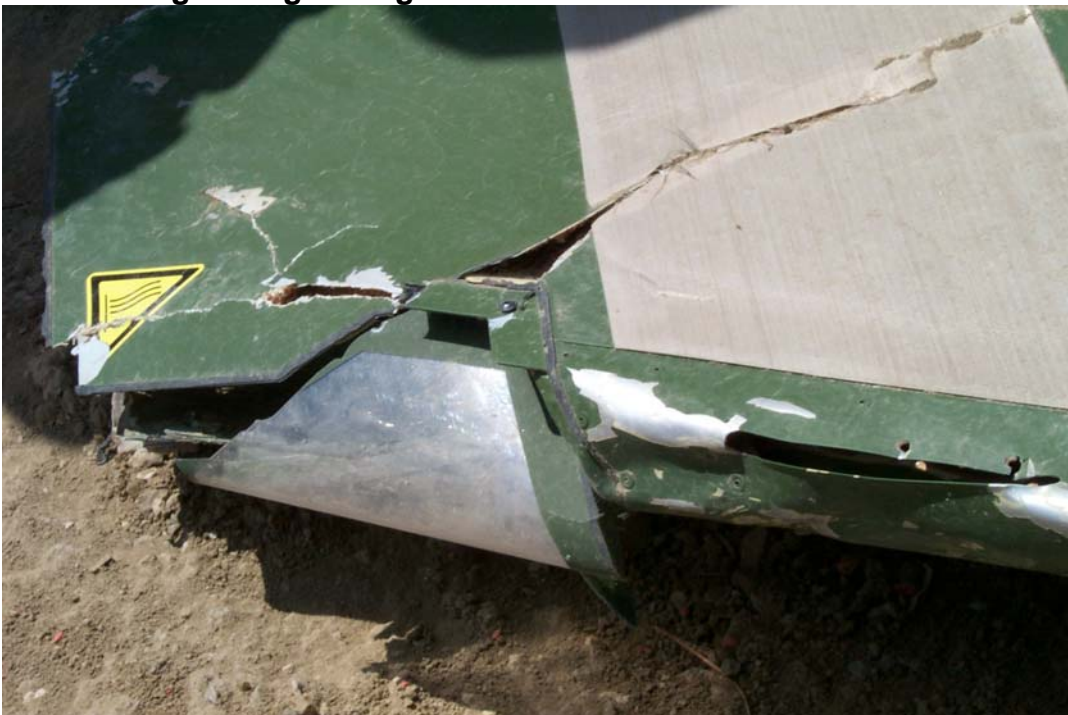
Photo 4: Right wing damage
